**NUMBER:** 23-041-21 REV. A

A-Pillar Water Drip

2018 - 2020	(JL)	Jeep Wrangler
2020	(JT)	Jeep Gladiator

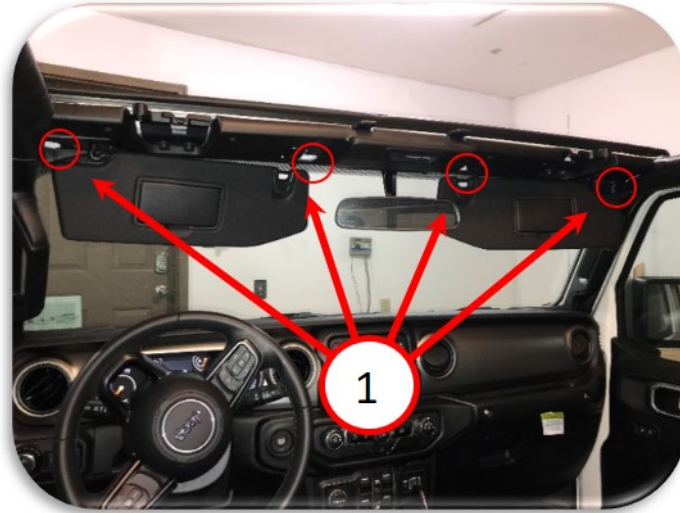
Fig. 1  
Windshield Frame Bolt Locations

1 - Windshield Frame Bolts

1. Remove top system at windshield frame header.
2. Remove current header seal and install new revision header seal. Refer to the detailed service procedures available in DealerCONNECT/Service Library under: Service Info 23 - Body / Weatherstrip/Seals / Weatherstrip, Header, Roof / Removal and Installation.
3. Remove the four windshield frame bolts (Fig. 1) .

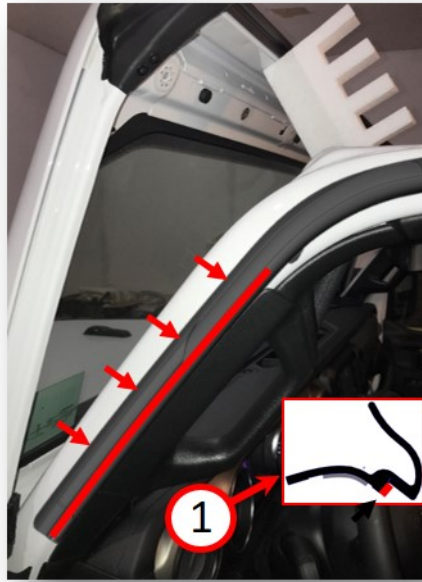
**Fig. 3**  
**Backward Alignment Of Diverter**

1 - Step In A-Pillar Water Diverter

7. Align rearward until step in A-pillar water diverter touches grab handle trim (Fig. 3) .

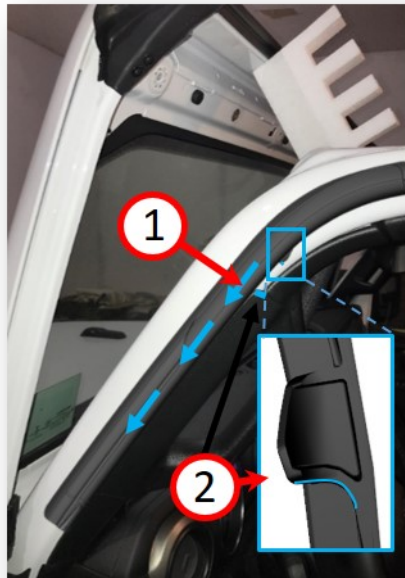
**Fig. 4**  
**Downward Alignment Of Diverter**

1 - Step In Trim  
2 - Locating Feature (Shown In Close-Up)

8. Align downward until locating feature catches step in the trim (Fig. 4) .

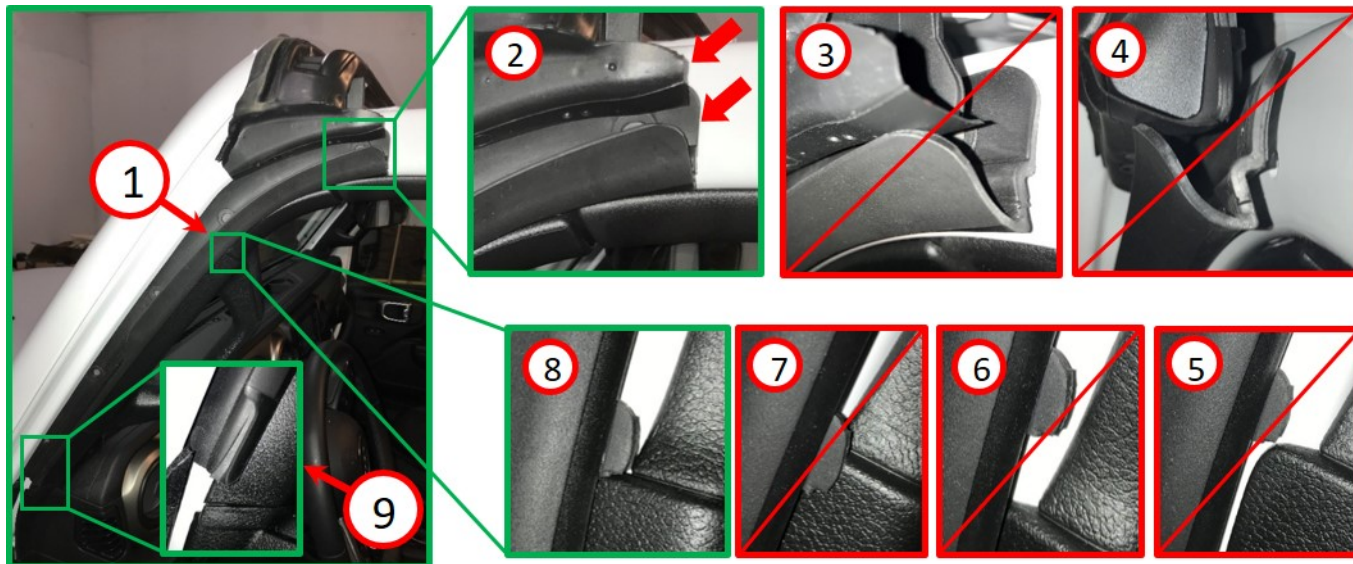
Fig. 6  
Position Checks

**NOTE: End of water diverter should line up near end of header seal, but should not touch in free state.**

- 1 - Locating Feature
- 2 - Example Of Correct Placement
- 3 - Part High, Interfering With Header Seal
- 4 - Tape Not Adhered
- 5 - Part Forward
- 6 - Part High
- 7 - Part Low
- 8 - Correct Position
- 9 - Correct Position Of The Bottom Of Diverter

10. Tip the windshield back into place to check the position (Fig. 6) .
